Restoration of Darche 1908 Flashlight Alarm

Ken Reindel (part 2)

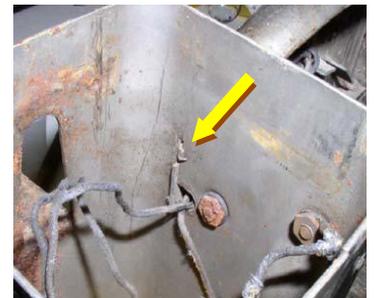
These tabs did not bend easily (lower left). Would they survive bending back down to re-secure the

silos, or would metal fatigue get the better of them? Hopefully they would survive, but we wouldn't know that until we were almost finished with reassembly.

Another problem was the bent tabs inside both cans, utilizing the top cross member to pull the silos together. There is no way this would survive removal. I thought about drilling holes for a draw bar between the left and right silos. Ultimately I elected to forego the idea, since the clock was rigid enough and the silos properly aligned with no assistance. It could be an option if the silos had an outward tilt as there is clearance behind the upper cross member to accommodate this.

A possible option for the tabs is to scribe a line where the tab meets the underside of the base, and then once disassembled drill holes in the tabs for taper pins just at the scribe lines. The advantage of this is it would allow as many disassemblies of the unit as desired. The tabs would never need to be bent over again. Speaking now with hindsight, this is what I would do if I were to start over.

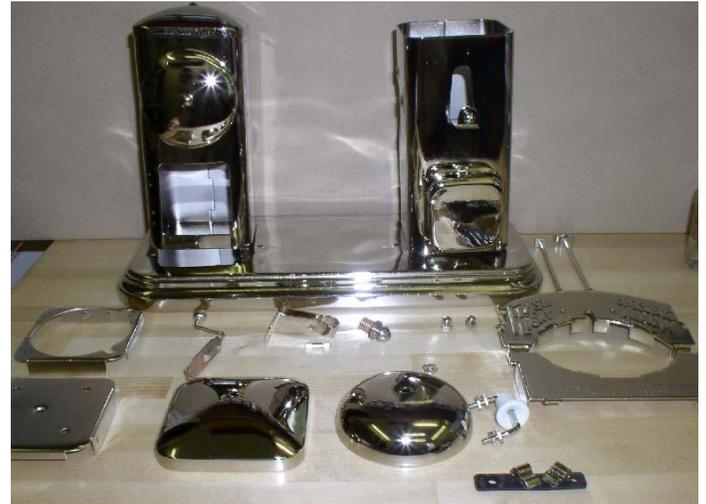
Shown below are the results of the first plating session. Another plating session completed the movement can, door and knob (which needed to be reconditioned on the lathe to restore the shape and knurl). The bank draw

bar, nuts, screws, alarm winding lever, and some other small parts are not shown, but were likewise plated.

Plating. We use 180 grit brown aluminum oxide to media blast all of our steel parts in preparation for plating because it never blurs fine details. This was one time I wished we used something more coarse. It took quite some time to wear away the corrosion, rust and plating. Each part was a project in itself, taking 2 hours or

more at the sandblaster. All told, it was a couple days' work just to strip the parts. After stripping, each part was pre-polished with a Britex wheel. This left a "Butler nickel" finish on the parts, many of which still had some nickel remaining after media blasting. This is how they would enter the copper tank.

It was interesting to note that there was very little copper found under the nickel. The nickel was extremely heavy and did not come off easily. This wasn't really a problem since the EPI E-Brite Ultra Cu formulation we use can plate over nickel quite well. The corrosion and rust were very slow to remove, but ultimately every part cleaned up very well. I felt a sense of encouragement as the parts were removed from the copper bath, fully plated and ready to restore/polish. Very few parts required solder filling. The base was in the worst shape of any part. Examination of sections of plating that were not damaged indicated many original blemishes in the factory finish. In an attempt to avoid over-restoration, some of the blemishes were left. There was a general texture to the metal that I did not want to lose. Applying one coat of copper did the job very nicely and provided a buffing layer that worked adequately for everything except the base.

Some of the internal parts were badly corroded. In general, this is inconsequential as long as the corrosion is removed and none of it passes through the part. We were fortunate. All of the parts were reusable, despite clear evidence of battery leakage eating away at internal components. One hour in the nickel tank and the parts were ready to go. Every part, down to the last screw, nut, lag and gadget, was cleaned, pre-polished, and nickel plated. The nickel plating took two 14 hour sessions to complete, not including the clock can.
