Update on the Big Ben Project

In our last Newsletter, we had started our discussion about the restoration of an electric Big Ben Chime Alarm. The project was one of the last to be completed in the Cedar Park shop. We discussed the problems with fabricating a second wheel gear and pinion for the clock, which was successfully completed. But there was much more to do. The case required stripping and repainting. Generally, we try to leave the nickel alone if it is still nice, and this one was. So, the nickel was masked and the black paint refinished. The results were quite nice as you can see from the picture above.

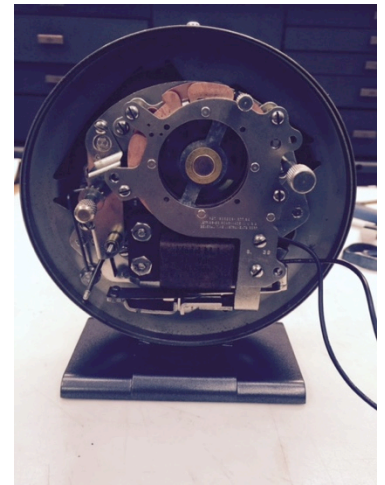
On some early Westclox (and other) electric alarm clocks you will find that setting the alarm involves turning a knob on the back of the clock with an accompanying “dial” located on the back as well. Looking at the picture to the right, you can plainly

see that this is the case with this clock. These “dials” are made of .040” plastic which, over time, dries out and becomes incredibly brittle. Even handling the part can cause damage to it. Unfortunately, most of these are found fairly deteriorated, broken, or even missing altogether. Again that was the case for these. We’ve had a “lifetime supply” of these miniature dials reproduced with .040” Lexan plastic. Above you can see that the replacement is quite nice and will serve for another 50 years or more.

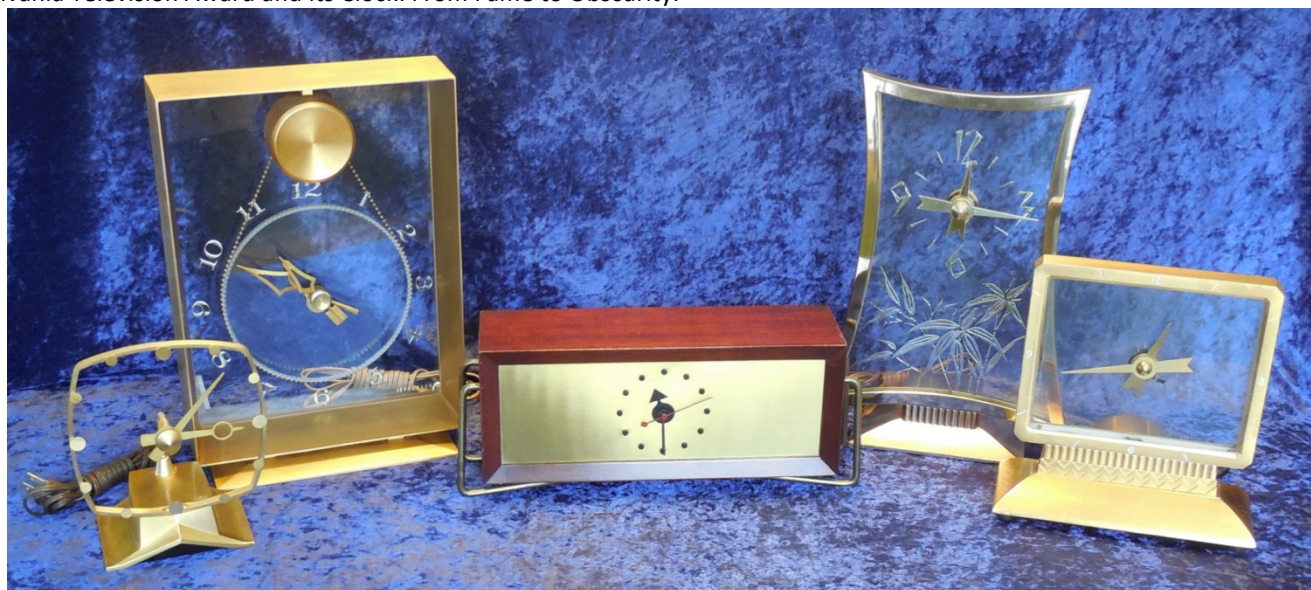
Left to right are Jefferson "Golden Secret", "Suspense" and "Contemporaire"; Haddon "South Wind"; and MasterCrafters "Fantasy"
